Stream Channel Alteration No. 13-57-08SA

Red Butte Creek

## Red Butte Creek Repairs LDS Church Sites Design Summary Report

Chevron Pipe Line Company Salt Lake City, Utah

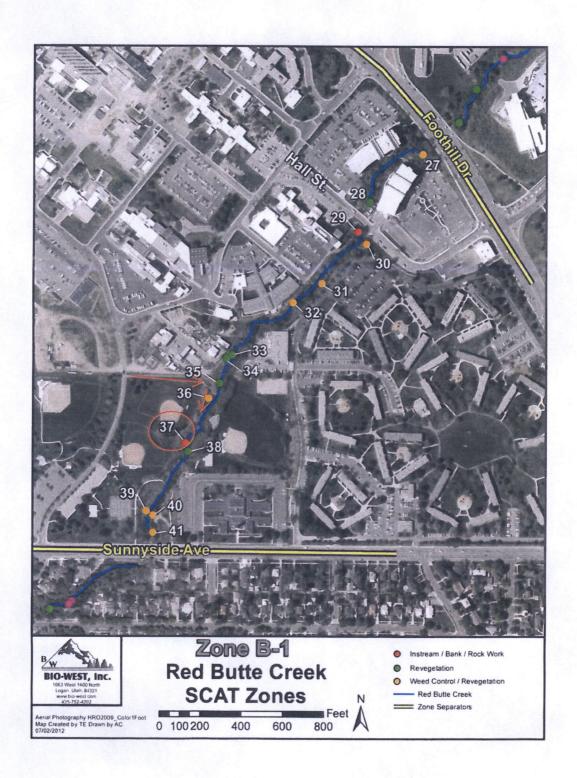
PROJECT RBC #37 PAGE | OF 4

The location of the storm drain outfall, marked as "VA of 4," is shown in the aerial photograph as Site #37 on page 1 of 4 in Attachment A. A photograph of the outfall headwall storm drain channel taken by Bio-West as Part of their Red Butte Creek Post-Oil Release Stream Channel, Physical Habitat, and Riparian Vegetation Evaluation Final Report is shown on page 2 of 4 in Attachment A. Access to the site requires travel down the west bank from accessed roadways, as shown in the aerial photograph, within an adjacent City park (Sunnyside Park).

Location and Proposed Access to Church Repair Site #37 (VA Of 4 Storm Drain Outfall).

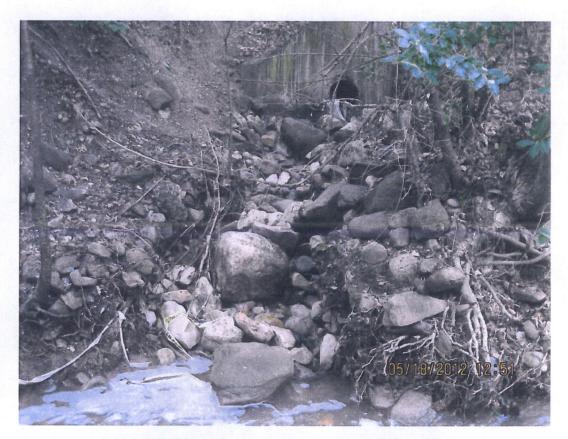
The 18-inch storm drain outfall (headwall) structure has an apron that is approximately 6 feet long, 5 feet wide at the end, and approximately 8-inches deep for energy dissipation. The storm drain channel leading running from the headwall to the Creek is a trapezoidal channel approximately four feet wide with rocky bottom and sides. The end of the channel drops approximately 2.5 feet down the bank into the Creek (see page 2 of 4 in Attachment B).

It is believed that cleaning activities damaged vegetation and shifted rocks that previously stabilized the bank at the inlet to the channel which allowed the heavy spring runoff of 2011 to cause additional movement of these rocks and erosion of the bank and drainage channel riprap.

Existing conditions at Recommendation Point #37, where outfall protection repairs are proposed.

- Key-in and rebuild the west main Creek bank with existing larger sized rock culled from the outfall channel appropriately sized hand placed riprap at the intersection with storm drain outfall channel.
- Rebuild the bottom and sides of the outfall channel with existing and imported angular riprap to provide an erosion-stable base.

The outfall channel peak velocity of 8.5 ft/ft with a floor slope of 4H:1V requires a minimum riprap size of 7-inch ( $D_{50}$ ) or equivalent County Gradation Class II rock (see page 7 of 10 in Attachment C). However, following direction from the County, the next larger gradation class (Class III,  $D_{50}$  = 12-inch) will be used for all supplemental repairs. See Salt Lake County Supplemental Specification to APWA Standard Specification 31 37 00 – Riprap or Rock Lining contained in Attachment D.

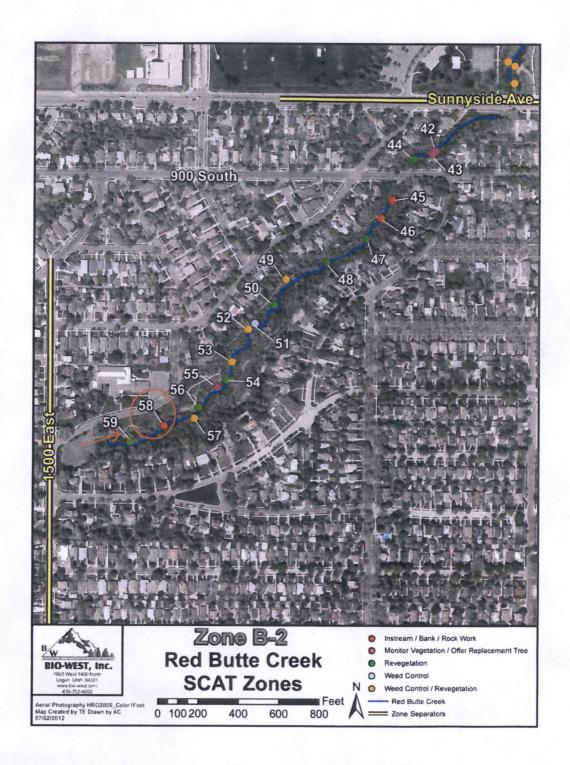
The location of the Creek bank repairs is shown in the aerial photograph as Site #58 on page 3 of 4 in Attachment A. A photograph of the bank and adjacent pathway was taken by Bio-West as Part of their Red Butte Creek Post-Oil Release Stream Channel, Physical Habitat, and Riparian Vegetation Evaluation Final Report are shown on page 4 of 4 in Attachment A. Access to the site is gained from the parking area and walking pathway adjoining 1500 East and Bonneview Drive as shown in the aerial photograph.

Location and Proposed Access to Church Repair Site #58 (Bank Erosion at Adjacent Trail).

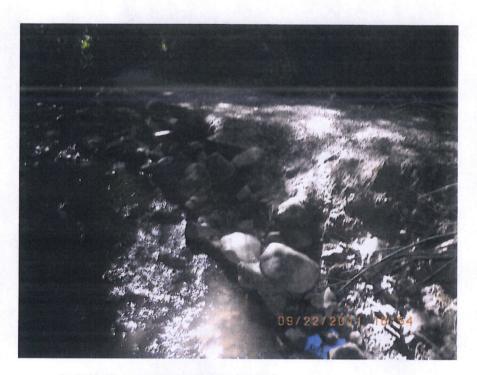
It is believed that cleaning activities damaged vegetation and shifted rocks that previously stabilized the bank at the inlet to the channel which allowed the heavy spring runoff of 2011 to cause additional movement of these rocks and erosion of the bank rock protection.

Eroded bank area at Recommendation Point #58.

Key-in and rebuild approximately 30 feet of the north Creek bank with appropriately sized hand placed riprap.

Calculations for the Creek hydraulics presented in Section 2.2.2 indicate that the banks are capable of containing the peak flow of 169 cfs. The peak velocity of 7.2 ft/s requires a minimum riprap size of 9-inch ( $D_{50}$ ) or equivalent County Gradation Class II for rock at on a slope of 1H:1V, (see page 10 of 10 in Attachment C). Further, following direction from the County, the next larger gradation class (Class III,  $D_{50}$  = 12-inch) will be used for the bank repair. See Salt Lake County Supplemental Specification to APWA Standard Specification 31 37 00 – Riprap or Rock Lining contained in Attachment D. The largest fraction of this rock (16-inch to 20-inch) will be keyed (excavated) into the channel bottom at least half of its diameter without protruding into the main channel or alter the downstream flow-line or hydraulics of the Creek. The remainder will be hand fit into the bank behind the bottom row at a 1H:1V batter. See Salt

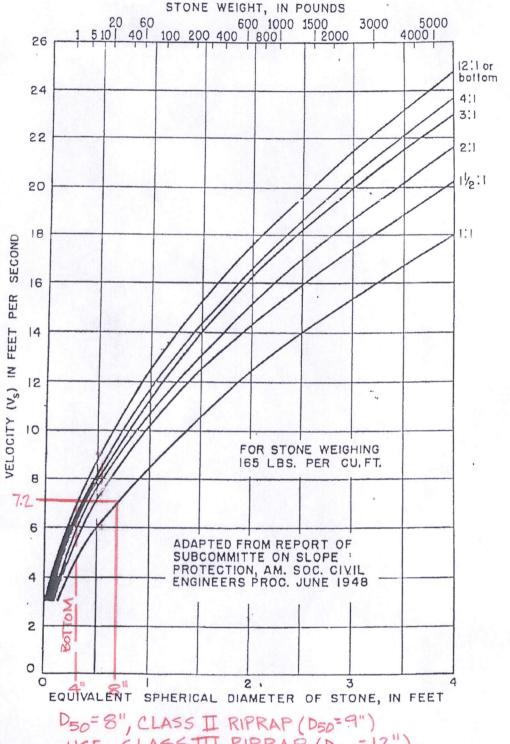
D50=8", CLASS II RIPRAP (D50=9")
USE CLASS III RIPRAP (D50=12")
